# IMU-Enhanced GNSS Receiver X1

## COMPETITIVE ANALYSIS

### TEST REPORT

This report summarizes the performances between Bynav GNSS/INS integrated system X1 (hereinafter referred to as X1) and other competitor receivers in 8 typical application scenarios. The results show that X1 can ensure real-time, continuous and reliable centimeter-level positioning results under harsh environments, providing geo-referencing for autonomous driving and unmanned systems.

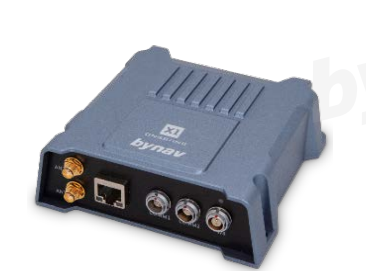
Figure2 X1

As shown in **Figure2**, X1 is a compact and highly integrated GNSS/INS receiver, whose specification is shown in **Table1**. X1-3 and X1-6 differ in IMU model as shown in **Table2**. (the system marked \* was not enabled in this test in order to compare with the competitor receiver.)

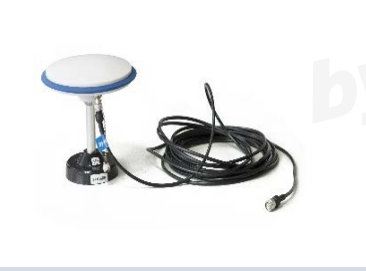
Figure3 GNSS antenna

The BY300 high precision survey antenna shown in **Figure3** supports GPS(L1/L2/L5), BDS(B1/B2), GLONASS(G1/G2) and Galileo(E1/E5b), with typical gain 40±2 dB.

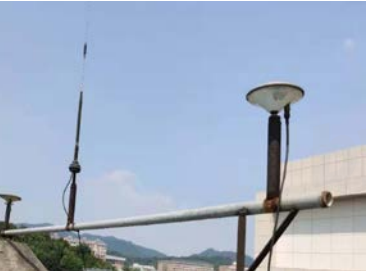
Figure4 Base Station

The base station was built with NovAtel 718D as shown in **Figure4**.

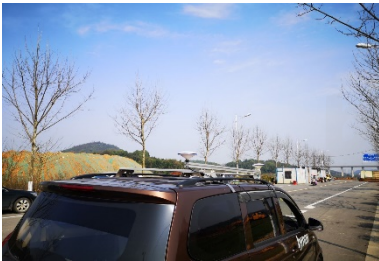
Figure1.1 Environment

The vehicle drove under open sky without blockage or signal interference. To verify the accuracy and consistency of the positioning results, the test performed several round-trips along the same road and lasted 13m26s.

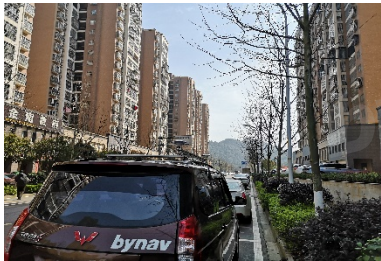
Table2.1 Environment

Under this scenario the vehicle drove through the high-rise buildings with a limited sky view, where all receivers were powered on and finished alignment. The test lasted 11m32s, of which the building blockage occupied about 50%.

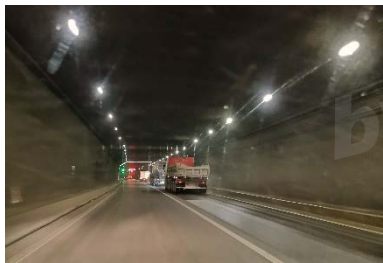
Figure6.1 Environment

Under this scenario the vehicle drove through a tunnel at a high speed after finished the initial alignment, and then turned around and went back from the same one. The driving speed was 80-100 km/h, and the total length of the tunnel is about 4.33km.

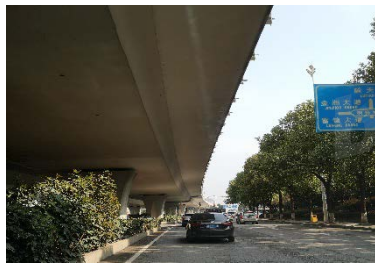
Figure8.1 Environment

Under this scenario the vehicle drove along an elevated road where satellite signals were mostly blocked. After finished the initial alignment, the vehicle drove into the test road section with several round-trips for 17m45s.
